**Flood Control Project Maintenance  
Levee Inspections****LMA District Cover Sheet  
Spring 2015 Levee Inspection Results****American River Flood Control District**

**Spring 2015 Levee Inspection Results**

**American River Flood Control District**

Waterway			Bank	Unit Miles
Unit No. 01 Arcade Creek			Left	2.08
	Spring (March - May)	Summer (June - August)	(September - November) Fall	Winter (December - February)
Unit Maintenance Rating (Fall Only)				
Date of Inspection	04/30/2015 - 04/30/2015			
DWR Inspector	Maksim Khashchuk			
Accompanied By	Richard Marck ARFCD

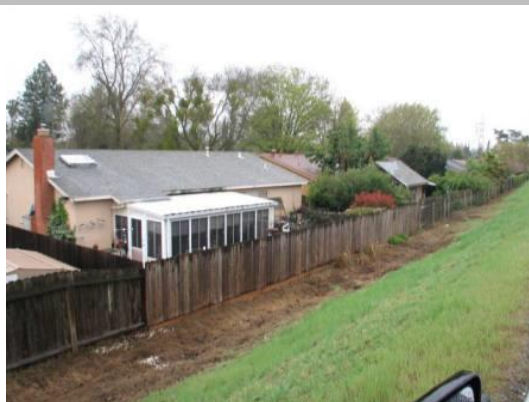
Photo 1 of 1 : SP\_2015\_NA0001\_55\_116\_20150317\_00099.jpg

LM Start	8.60	Rating **	U	Issue No.	116
LM End	8.60	Issue Type +	En	Location *	LS
Category	Earthen Levee			GPS Latitude/Longitude	
				Start	End
Item	Encroachments			38.564133 °	38.564133 °
				-121.387318 °	-121.387318 °
DWR ID	DWR_NA0001_04_s _ 2012_116				
Action/Comments					
Fence					
Inspector Comments: Wood privacy fence within 10-ft of levee toe obstructs access and visibility.

03/16/2012 Wood privacy fence completely obstructs access and visibility.

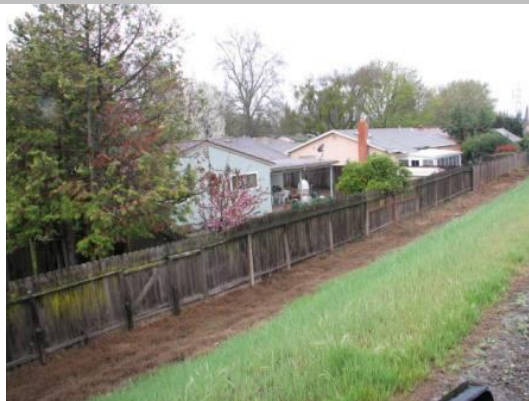
Photo 1 of 1 : SP\_2015\_NA0001\_55\_118\_20150317\_00101.jpg

LM Start	8.61	Rating **	U	Issue No.	118
LM End	8.61	Issue Type +	En	Location *	LS
Category	Earthen Levee			GPS Latitude/Longitude	
				Start	End
Item	Encroachments			38.564133 °	38.564133 °
				-121.387092 °	-121.387092 °
DWR ID	DWR_NA0001_04_s_2012_118				
Action/Comments					
Fence					
Inspector Comments: Wood privacy fence within 10-ft of levee toe obstructs access and visibility.

03/16/2012 Wood privacy fence completely obstructs access and visibility.

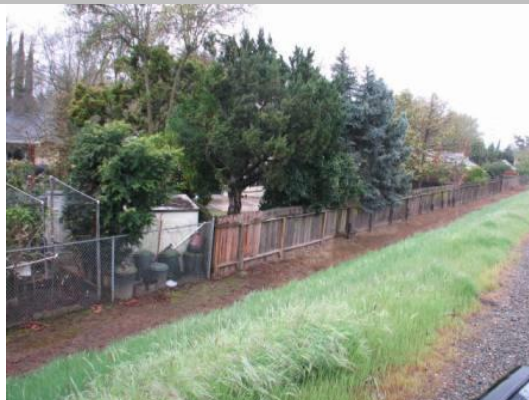
Photo 1 of 1 : SP\_2015\_NA0001\_55\_119\_20150317\_00102.jpg

LM Start	8.63	Rating **	U	Issue No.	119
LM End	8.63	Issue Type +	En	Location *	LS
Category	Earthen Levee			GPS Latitude/Longitude	
				Start	End
Item	Encroachments			38.564217 °	38.564217 °
				-121.386846 °	-121.386846 °
DWR ID	DWR_NA0001_04_s_2012_119				
Action/Comments					
Fence					
Inspector Comments: Wood privacy fence within 10-ft of levee toe obstructs access and visibility.

03/16/2012 Wood privacy fence completely obstructs access and visibility.

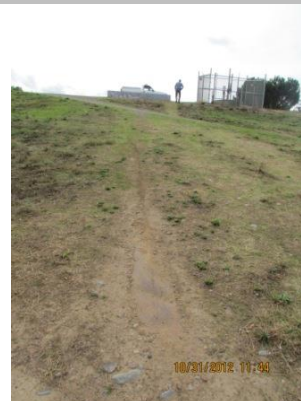
Photo 1 of 2 : SP\_2015\_NA0001\_55\_175\_20150317\_00152.jpg

LM Start	9.41	Rating **	A/W	Issue No.	175
LM End	9.41	Issue Type +	En	Location *	WS
Category	Earthen Levee			GPS Latitude/Longitude	
				Start	End
Item	Encroachments			38.566700 °	38.566700 °
				-121.372961 °	-121.372961 °
DWR ID	DWR_NA0001_04_s _ 2012_175				
Action/Comments					
Pipe					
Inspector Comments: Flap gates in good condition. Pipe is exposed at waterside toe.

View of exposed pipe at waterside toe.

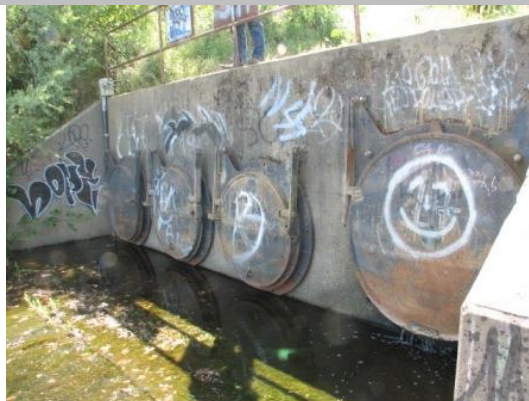
Photo 2 of 2 : SP\_2015\_NA0001\_55\_175\_20150317\_00153.jpg

LM Start	<b>9.41</b>	Rating **	A/W	Issue No.	<b>175 (cont)</b>
LM End	<b>9.41</b>	Issue Type +	En	Location *	WS

Drainage outfall to American River.

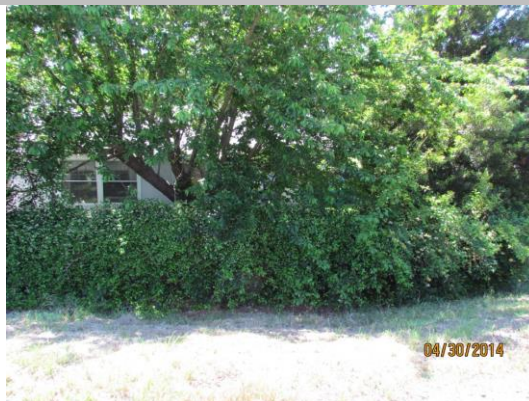
Photo 1 of 1 : SP\_2015\_NA0001\_55\_236\_20150317\_00185.jpg

LM Start	9.48	Rating **	M	Issue No.	236
LM End	9.48	Issue Type +	En	Location *	LS
Category	Earthen Levee			GPS Latitude/Longitude	
				Start	End
Item	Vegetation			38.566948 °	38.566948 °
				-121.371562 °	-121.371562 °
DWR ID	DWR_NA0001_04_s _ 2012_236				
Action/Comments					
Landscaping					
Inspector Comments: Landscaping within 10-ft of levee toe.

View of the landscaping at the landside levee to obstructing visibility and access.

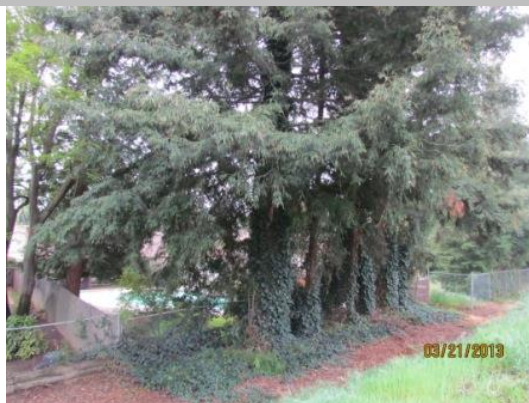
Photo 1 of 1 : SP\_2015\_NA0001\_55\_237\_20150317\_00186.jpg

LM Start	9.48	Rating **	M	Issue No.	237
LM End	9.48	Issue Type +	En	Location *	LS
Category	Earthen Levee			GPS Latitude/Longitude	
				Start	End
Item	Vegetation			38.566938 °	38.566938 °
				-121.371550 °	-121.371550 °
DWR ID	DWR_NA0001_04_s _ 2012_237				
Action/Comments					
Landscaping Inspector Comments: Redwoods and ivy along fence within 10-ft of levee toe.

View of landscaping at levee toe.

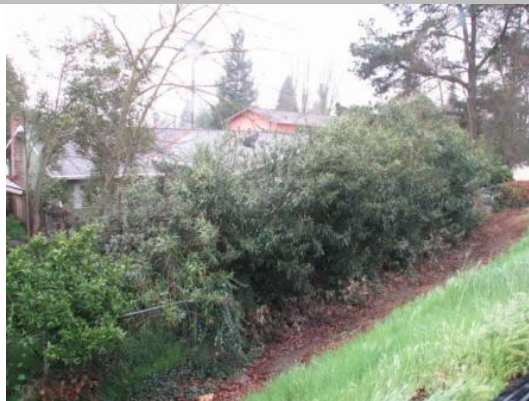
Photo 1 of 1 : SP\_2015\_NA0001\_55\_121\_20150317\_00103.jpg

LM Start	9.52	Rating **	U	Issue No.	121
LM End	9.52	Issue Type +	En	Location *	LS
Category	Earthen Levee			GPS Latitude/Longitude	
				Start	End
Item	Vegetation			38.567058 °	38.567058 °
				-121.370954 °	-121.370954 °
DWR ID	DWR_NA0001_04_s _ 2012_121				
Action/Comments					
Landscaping					
Inspector Comments: Oleander bushes and shrubs within 10-ft of landside toe.

03/16/2012 Landscaping obstructs visibility and access.

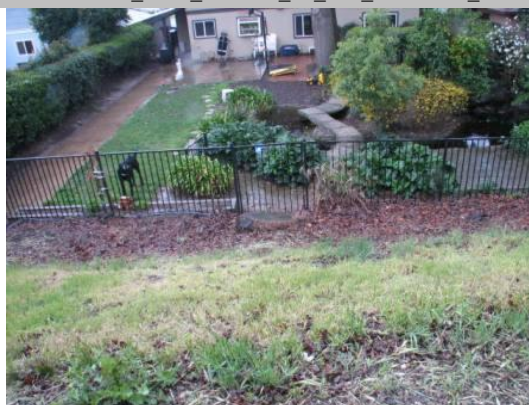
Photo 1 of 1 : SP\_2015\_NA0001\_55\_123\_20150317\_00105.jpg

LM Start	9.57	Rating **	N	Issue No.	123
LM End	9.57	Issue Type +	Ma	Location *	LS
Category	Earthen Levee			GPS Latitude/Longitude	
				Start	End
Item	Trim / Thin Trees			38.567285 °	38.567285 °
				-121.369964 °	-121.369964 °
DWR ID	DWR_NA0001_04_s_2012_123				
Action/Comments					
Tree stumps. Inspector Comments: Trees, bushes and ground cover within 10-ft of levee toe.

03/16/2012 Large tree stump at levee toe.

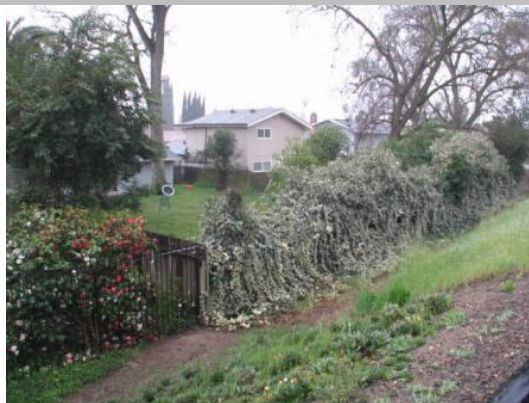
Photo 1 of 1 : SP\_2015\_NA0001\_55\_125\_20150317\_00107.jpg

LM Start	9.60	Rating **	U	Issue No.	125
LM End	9.60	Issue Type +	En	Location *	LS
Category	Earthen Levee			GPS Latitude/Longitude	
				Start	End
Item	Vegetation			38.567360 °	38.567360 °
				-121.369555 °	-121.369555 °
DWR ID	DWR_NA0001_04_s_2012_125				
Action/Comments					
Landscaping					
Inspector Comments: Dense golden ivy on C/L fence obstructs access and visibility.

03/16/2012 Landscaping obstructs visibility and access.

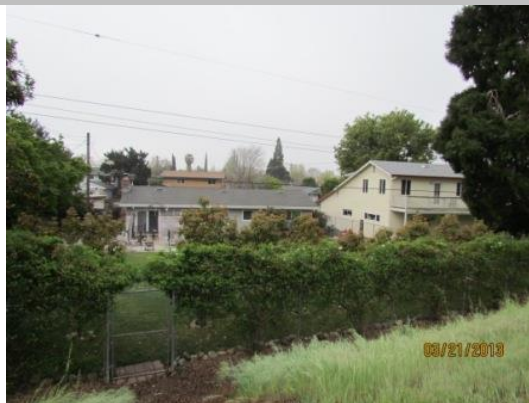
Photo 1 of 1 : SP\_2015\_NA0001\_55\_129\_20150317\_00110.jpg

LM Start	9.67	Rating **	M	Issue No.	129
LM End	9.67	Issue Type +	En	Location *	LS
Category	Earthen Levee			GPS Latitude/Longitude	
				Start	End
Item	Vegetation			38.567594 °	38.567594 °
				-121.368195 °	-121.368195 °
DWR ID	DWR_NA0001_04_s_2012_129				
Action/Comments					
Landscaping					
Inspector Comments: Trees and vines along C/L fence within 10-ft of levee toe.

View of landscaping at levee toe.

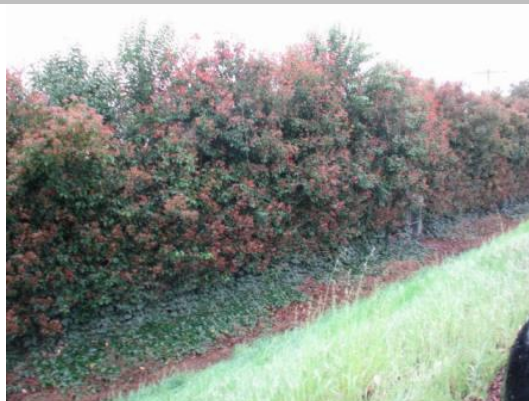
Photo 1 of 1 : SP\_2015\_NA0001\_55\_130\_20150317\_00111.jpg

LM Start	9.69	Rating **	U	Issue No.	130
LM End	9.69	Issue Type +	En	Location *	LS
Category	Earthen Levee			GPS Latitude/Longitude	
				Start	End
Item	Vegetation			38.567626 °	38.567626 °
				-121.367921 °	-121.367921 °
DWR ID	DWR_NA0001_04_s_2012_130				
Action/Comments					
Landscaping					
Inspector Comments: Tall hedge obstructs access and visibility.

03/16/2012 Tall hedge obstructs visibility and access.

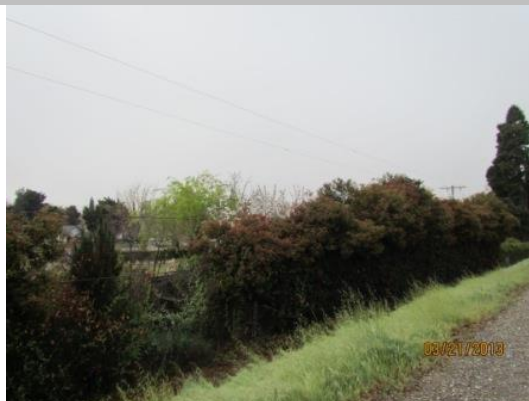
Photo 1 of 1 : SP\_2015\_NA0001\_55\_131\_20150317\_00112.jpg

LM Start	9.70	Rating **	M	Issue No.	131
LM End	9.70	Issue Type +	En	Location *	LS
Category	Earthen Levee			GPS Latitude/Longitude	
				Start	End
Item	Vegetation			38.567680 °	38.567680 °
				-121.367674 °	-121.367674 °
DWR ID	DWR_NA0001_04_s_2012_131				
Action/Comments					
Landscaping					
Inspector Comments: Tall hedge obstructs access and visibility.

View of landscaping at levee toe.

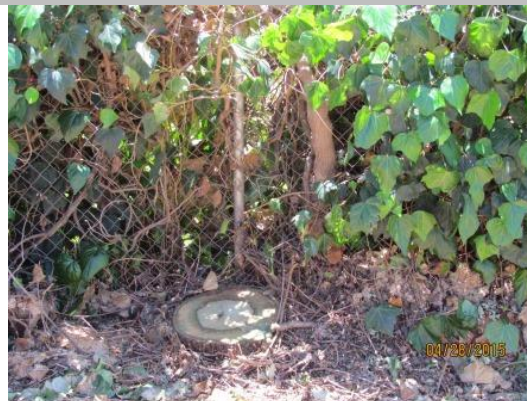
Photo 1 of 1 : SP\_2015\_NA0001\_55\_234\_20150504\_00217.jpg

LM Start	9.72	Rating **	N	Issue No.	234
LM End	9.72	Issue Type +	Ma	Location *	LS
Category	Earthen Levee			GPS Latitude/Longitude	
				Start	End
Item	Trim / Thin Trees			38.567761 °	38.567761 °
				-121.367363 °	-121.367363 °
DWR ID	DWR_NA0001_04_s_2015_234				
Action/Comments					
Tree stumps.

View of the tree stump at the landside levee toe.

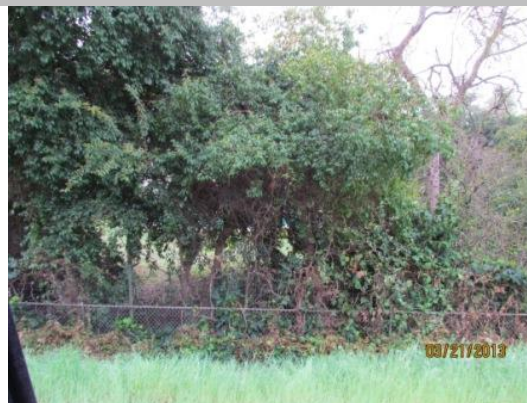
Photo 1 of 1 : SP\_2015\_NA0001\_55\_132\_20150317\_00113.jpg

LM Start	9.72	Rating **	M	Issue No.	132
LM End	9.72	Issue Type +	En	Location *	LS
Category	Earthen Levee			GPS Latitude/Longitude	
				Start	End
Item	Vegetation			38.567772 °	38.567772 °
				-121.367227 °	-121.367227 °
DWR ID	DWR_NA0001_04_s_2012_132				
Action/Comments					
Landscaping Inspector Comments: Trees and ivy on levee slope obstruct access and visibility.

View of obstructive landscaping.

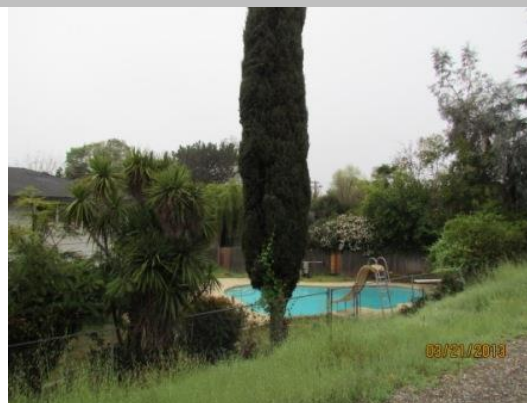
Photo 1 of 1 : SP\_2015\_NA0001\_55\_133\_20150317\_00114.jpg

LM Start	9.74	Rating **	M	Issue No.	133
LM End	9.74	Issue Type +	En	Location *	LS
Category	Earthen Levee			GPS Latitude/Longitude	
				Start	End
Item	Vegetation			38.567856 °	38.567856 °
				-121.366892 °	-121.366892 °
DWR ID	DWR_NA0001_04_s_2012_133				
Action/Comments					
Landscaping					
Inspector Comments: Lemon tree, palm, sky pencil and ivy planted within 10-ft of levee toe obstructs access and visibility.

View of landscaping at levee toe.

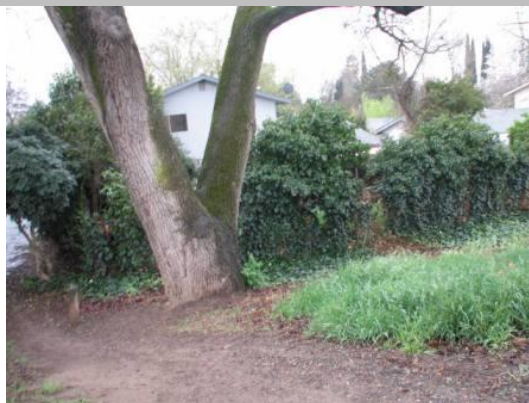
Photo 1 of 1 : SP\_2015\_NA0001\_55\_135\_20150317\_00116.jpg

LM Start	9.89	Rating **	M	Issue No.	135
LM End	9.89	Issue Type +	En	Location *	LS
Category	Earthen Levee			GPS Latitude/Longitude	
				Start	End
Item	Vegetation			38.568446 °	38.568446 °
				-121.364385 °	-121.364385 °
DWR ID	DWR_NA0001_04_s _ 2012_135				
Action/Comments					
Landscaping					
Inspector Comments: Tall hedge and ivy within 10-ft of landside levee toe.

03/16/2012 Landscaping is obstructing visibility.

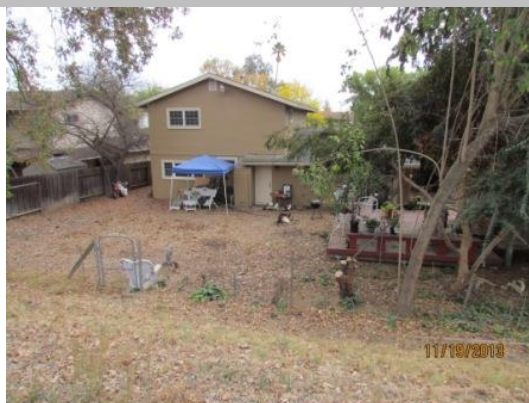
Photo 1 of 1 : SP\_2015\_NA0001\_55\_136\_20150317\_00117.jpg

LM Start	9.95	Rating **	M	Issue No.	136
LM End	9.95	Issue Type +	En	Location *	LS
Category	Earthen Levee			GPS Latitude/Longitude	
				Start	End
Item	Encroachments			38.568714 °	38.568714 °
				-121.363257 °	-121.363257 °
DWR ID	DWR_NA0001_04_s _ 2012_136				
Action/Comments					
Fence					
Inspector Comments: Wire fence within 10-ft of landside levee toe.

View of the fence and tree stump at the landside levee toe.

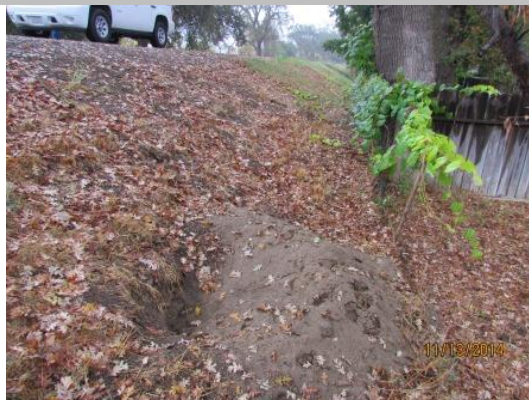
Photo 1 of 1 : SP\_2015\_NA0001\_55\_239\_20150317\_00188.jpg

LM Start	9.96	Rating **	A/W	Issue No.	239
LM End	9.96	Issue Type +	Ma	Location *	LS
Category	Earthen Levee			GPS Latitude/Longitude	
				Start	End
Item	Animal Control			38.568773 °	38.568773 °
				-121.363057 °	-121.363057 °
DWR ID	DWR_NA0001_04_f_2014_239				
Action/Comments					
Exterminate rodents and backfill and compact or grout burrows.

View of several large rodent burrows.

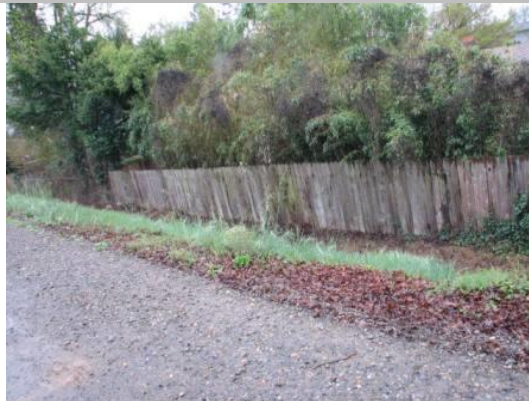
Photo 1 of 1 : SP\_2015\_NA0001\_55\_138\_20150317\_00119.jpg

LM Start	10.00	Rating **	U	Issue No.	138
LM End	10.00	Issue Type +	En	Location *	LS
Category	Earthen Levee			GPS Latitude/Longitude	
				Start	End
Item	Encroachments			38.568953 °	38.568953 °
				-121.362396 °	-121.362396 °
DWR ID	DWR_NA0001_04_s_2012_138				
Action/Comments					
Fence					
Inspector Comments: 03/16/2012 Wood privacy fence completely obstructs visibility and access.

03/16/2012 Wood privacy fence completely obstructs access and visibility.

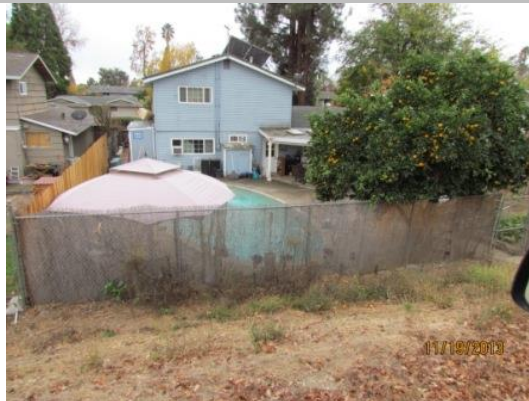
Photo 1 of 1 : SP\_2015\_NA0001\_55\_202\_20150317\_00174.jpg

LM Start	10.03	Rating **	A/W	Issue No.	202
LM End	10.03	Issue Type +	En	Location *	LS
Category	Earthen Levee			GPS Latitude/Longitude	
				Start	End
Item	Encroachments			38.569111 °	38.569111 °
				-121.361921 °	-121.361921 °
DWR ID	DWR_NA0001_04_s_2013_202				
Action/Comments					
Pool					
Inspector Comments: Pool filled with water.

View of the pool filled with water.

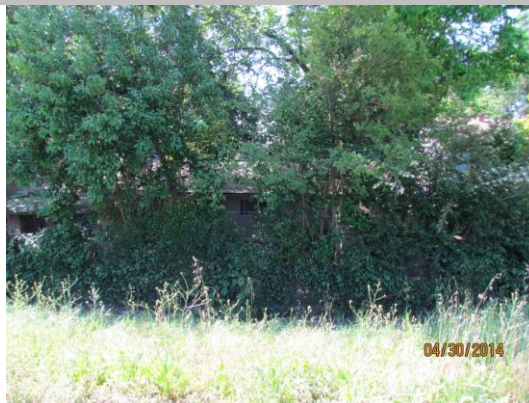
Photo 1 of 1 : SP\_2015\_NA0001\_55\_245\_20150317\_00191.jpg

LM Start	10.06	Rating **	U	Issue No.	245
LM End	10.06	Issue Type +	En	Location *	LS
Category	Earthen Levee			GPS Latitude/Longitude	
				Start	End
Item	Encroachments			38.569247 °	38.569247 °
				-121.361315 °	-121.361315 °
DWR ID	DWR_NA0001_04_s_2014_245				
Action/Comments					
Fence					
Inspector Comments: Rod fence covered with vegetation within 10ft of levee toe.

View of the fence at the landside levee toe.

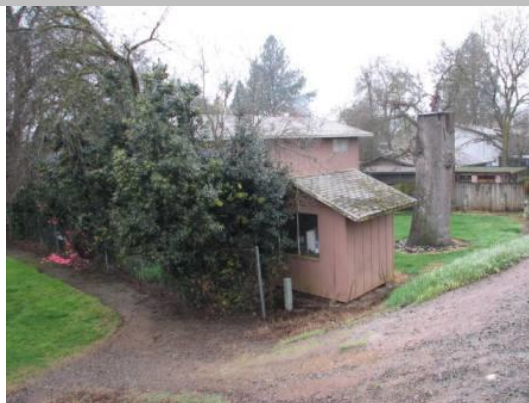
Photo 1 of 1 : SP\_2015\_NA0001\_55\_176\_20150317\_00154.jpg

LM Start	10.08	Rating **	U	Issue No.	176
LM End	10.08	Issue Type +	En	Location *	LS
Category	Earthen Levee			GPS Latitude/Longitude	
				Start	End
Item	Encroachments			38.569293 °	38.569293 °
				-121.361002 °	-121.361002 °
DWR ID	DWR_NA0001_04_s_2012_176				
Action/Comments					
Building

03/16/2012 Wood structure within 15' of levee toe.

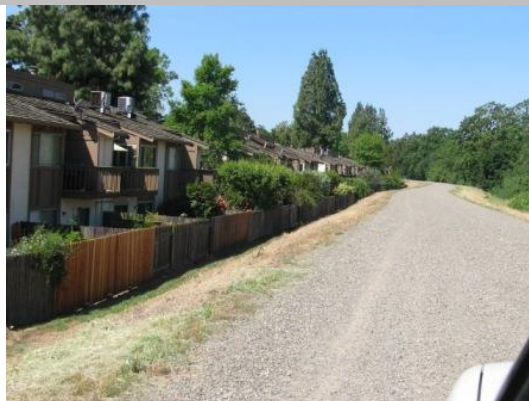
Photo 1 of 1 : SP\_2015\_NA0001\_55\_142\_20150317\_00122.jpg

LM Start	10.28	Rating **	U	Issue No.	142
LM End	10.30	Issue Type +	En	Location *	LS
Category	Earthen Levee			GPS Latitude/Longitude	
				Start	End
Item	Encroachments			38.570175 °	38.570229 °
				-121.357390 °	-121.357041 °
DWR ID	DWR_NA0001_04_s_2012_142				
Action/Comments					
Fence					
Inspector Comments: Wooden fence behind six apartment units is within 10-ft of levee slope.

Wooden fence behind apartments within 10' of levee toe.

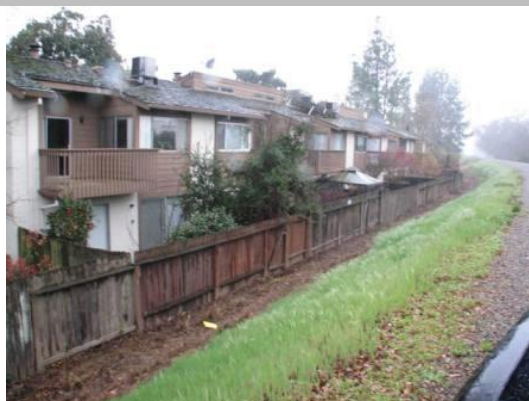
Photo 1 of 1 : SP\_2015\_NA0001\_55\_146\_20150317\_00126.jpg

LM Start	10.30	Rating **	U	Issue No.	146
LM End	10.32	Issue Type +	En	Location *	LS
Category	Earthen Levee			GPS Latitude/Longitude	
				Start	End
Item	Encroachments			38.570225 °	38.570245 °
				-121.357014 °	-121.356791 °
DWR ID	DWR_NA0001_04_s_2012_146				
Action/Comments					
Fence					
Inspector Comments: Wooden fence behind 6 apartments.

03/16/2012 Wood privacy fence completely obstructs access and visibility.

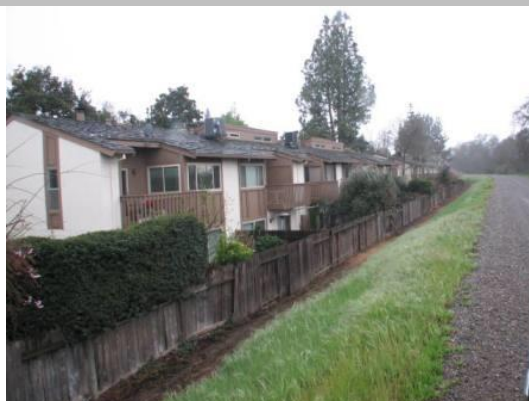
Photo 1 of 1 : SP\_2015\_NA0001\_55\_143\_20150317\_00123.jpg

LM Start	10.32	Rating **	U	Issue No.	143
LM End	10.34	Issue Type +	En	Location *	LS
Category	Earthen Levee			GPS Latitude/Longitude	
				Start	End
Item	Encroachments			38.570257 °	38.570297 °
				-121.356783 °	-121.356403 °
DWR ID	DWR_NA0001_04_s_2012_143				
Action/Comments					
Fence					
Inspector Comments: Wooden fence behind six apartment units is within 10-ft of levee slope.

03/16/2012 Wood privacy fence completely obstructs access and visibility.

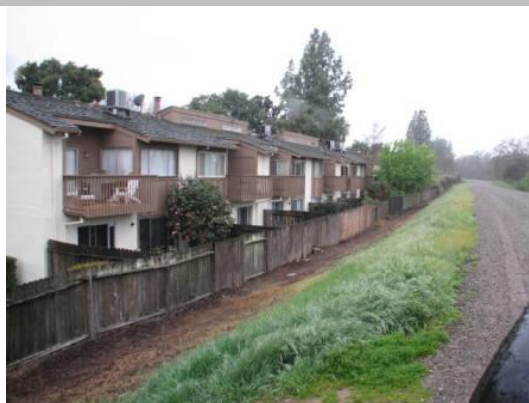
Photo 1 of 1 : SP\_2015\_NA0001\_55\_145\_20150317\_00125.jpg

LM Start	10.38	Rating **	U	Issue No.	145
LM End	10.41	Issue Type +	En	Location *	LS
Category	Earthen Levee			GPS Latitude/Longitude	
				Start	End
Item	Encroachments			38.570417 °	38.570500 °
				-121.355625 °	-121.355151 °
DWR ID	DWR_NA0001_04_s _ 2012_145				
Action/Comments					
Fence					
Inspector Comments: Wooden fence behind six apartment units is within 10-ft of levee slope.

03/16/2012 Wood privacy fence completely obstructs access and visibility.

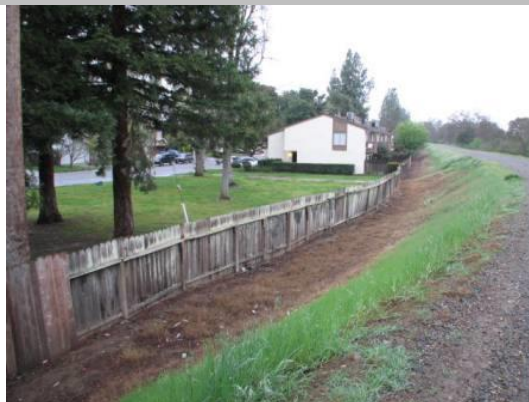
Photo 1 of 1 : SP\_2015\_NA0001\_55\_147\_20150317\_00127.jpg

LM Start	10.43	Rating **	U	Issue No.	147
LM End	10.43	Issue Type +	En	Location *	LS
Category	Earthen Levee			GPS Latitude/Longitude	
				Start	End
Item	Encroachments			38.570542 °	38.570542 °
				-121.354772 °	-121.354772 °
DWR ID	DWR_NA0001_04_s _ 2012_147				
Action/Comments					
Fence					
Inspector Comments: Wooden privacy fence.

03/16/2012 Wood privacy fence completely obstructs access and visibility.

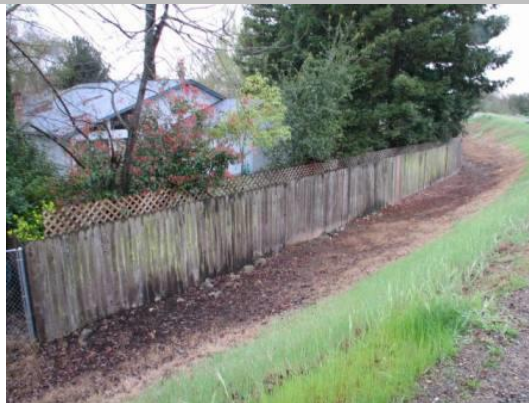
Photo 1 of 1 : SP\_2015\_NA0001\_55\_148\_20150317\_00128.jpg

LM Start	10.45	Rating **	U	Issue No.	148
LM End	10.45	Issue Type +	En	Location *	LS
Category	Earthen Levee			GPS Latitude/Longitude	
				Start	End
Item	Encroachments			38.570524 °	38.570524 °
				-121.354359 °	-121.354359 °
DWR ID	DWR_NA0001_04_s_2012_148				
Action/Comments					
Fence					
Inspector Comments: Wooden privacy fence obstructs visibility and access.

03/16/2012 Wood privacy fence completely obstructs access and visibility.

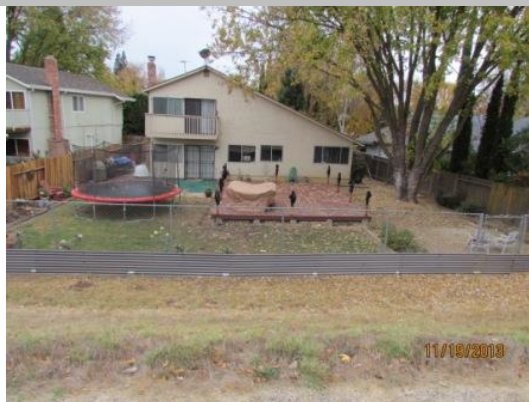
Photo 1 of 1 : SP\_2015\_NA0001\_55\_180\_20150317\_00158.jpg

LM Start	10.47	Rating **	M	Issue No.	180
LM End	10.47	Issue Type +	En	Location *	LS
Category	Earthen Levee			GPS Latitude/Longitude	
				Start	End
Item	Encroachments			38.570397 °	38.570397 °
				-121.354084 °	-121.354084 °
DWR ID	DWR_NA0001_04_s_2012_180				
Action/Comments					
Fence					
Inspector Comments: Chainlink fence partially obstructs, currently visibility is unobstructed.

Chainlink fence is partially obstructing visibility and access.

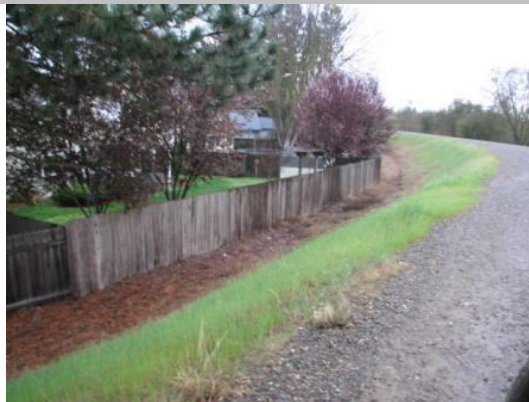
Photo 1 of 1 : SP\_2015\_NA0001\_55\_149\_20150317\_00129.jpg

LM Start	10.48	Rating **	U	Issue No.	149
LM End	10.48	Issue Type +	En	Location *	LS
Category	Earthen Levee			GPS Latitude/Longitude	
				Start	End
Item	Encroachments			38.570234 °	38.570234 °
				-121.353862 °	-121.353862 °
DWR ID	DWR_NA0001_04_s_2012_149				
Action/Comments					
Fence					
Inspector Comments: Wooden privacy fence is within 10-ft of levee toe.

03/16/2012 Wood privacy fence completely obstructs access and visibility.

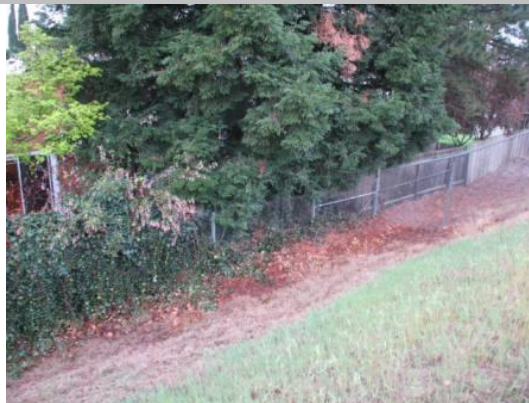
Photo 1 of 1 : SP\_2015\_NA0001\_55\_150\_20150317\_00130.jpg

LM Start	10.49	Rating **	U	Issue No.	150
LM End	10.49	Issue Type +	En	Location *	LS
Category	Earthen Levee			GPS Latitude/Longitude	
				Start	End
Item	Encroachments			38.570095 °	38.570095 °
				-121.353807 °	-121.353807 °
DWR ID	DWR_NA0001_04_s _ 2012_150				
Action/Comments					
Fence					
Inspector Comments: Wooden privacy fence within 10-ft of levee toe.

03/16/2012 Wood privacy fence completely obstructs access and visibility.

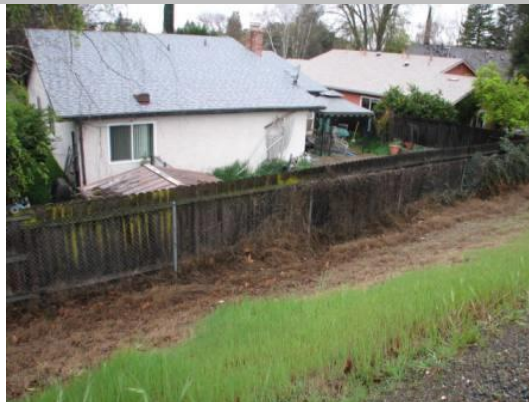
Photo 1 of 1 : SP\_2015\_NA0001\_55\_151\_20150317\_00131.jpg

LM Start	10.51	Rating **	U	Issue No.	151
LM End	10.51	Issue Type +	En	Location *	LS
Category	Earthen Levee			GPS Latitude/Longitude	
				Start	End
Item	Encroachments			38.569921 °	38.569921 °
				-121.353643 °	-121.353643 °
DWR ID	DWR_NA0001_04_s _ 2012_151				
Action/Comments					
Fence					
Inspector Comments: Wooden privacy fence within 10-ft of levee toe.

03/16/2012 Wood privacy fence completely obstructs access and visibility.

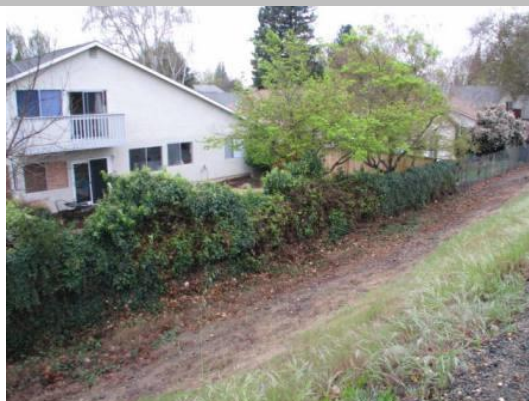
Photo 1 of 1 : SP\_2015\_NA0001\_55\_153\_20150317\_00133.jpg

LM Start	10.57	Rating **	U	Issue No.	153
LM End	10.57	Issue Type +	En	Location *	LS
Category	Earthen Levee			GPS Latitude/Longitude	
				Start	End
Item	Encroachments			38.569166 °	38.569166 °
				-121.353272 °	-121.353272 °
DWR ID	DWR_NA0001_04_s_2012_153				
Action/Comments					
Fence					
Inspector Comments: Wooden privacy fence and ivy within 10-ft of levee toe.

03/16/2012 Wood privacy fence completely obstructs access and visibility.

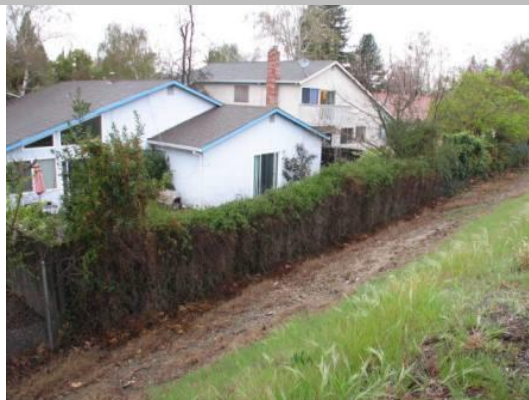
Photo 1 of 1 : SP\_2015\_NA0001\_55\_154\_20150317\_00134.jpg

LM Start	10.57	Rating **	U	Issue No.	154
LM End	10.57	Issue Type +	En	Location *	LS
Category	Earthen Levee			GPS Latitude/Longitude	
				Start	End
Item	Encroachments			38.569020 °	38.569020 °
				-121.353313 °	-121.353313 °
DWR ID	DWR_NA0001_04_s_2012_154				
Action/Comments					
Fence					
Inspector Comments: Wooden privacy fence within 10-ft of levee toe.

03/16/2012 Wood privacy fence completely obstructs access and visibility.

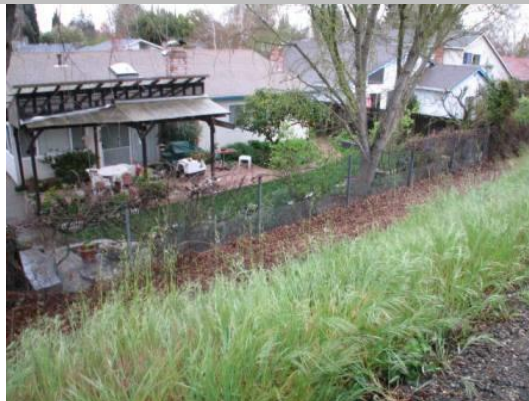
Photo 1 of 1 : SP\_2015\_NA0001\_55\_155\_20150317\_00135.jpg

LM Start	10.59	Rating **	M	Issue No.	155
LM End	10.59	Issue Type +	En	Location *	LS
Category	Earthen Levee			GPS Latitude/Longitude	
				Start	End
Item	Vegetation			38.568892 °	38.568892 °
				-121.353162 °	-121.353162 °
DWR ID	DWR_NA0001_04_s_2012_155				
Action/Comments					
Landscaping					
Inspector Comments: Trees and bushes are within 10-ft of the levee toe.

03/16/2012 Trees and bushes within 10' of levee toe.

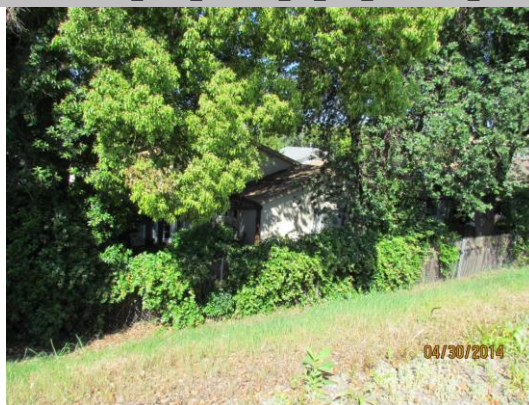
Photo 1 of 1 : SP\_2015\_NA0001\_55\_156\_20150317\_00136.jpg

LM Start	10.60	Rating **	U	Issue No.	156
LM End	10.60	Issue Type +	En	Location *	LS
Category	Earthen Levee			GPS Latitude/Longitude	
				Start	End
Item	Encroachments			38.568713 °	38.568713 °
				-121.353150 °	-121.353150 °
DWR ID	DWR_NA0001_04_s_2012_156				
Action/Comments					
Fence					
Inspector Comments: Wooden privacy fence and landscaping within 10-ft of levee toe.

View of the fence at the landside levee toe obstructing visibility and access.

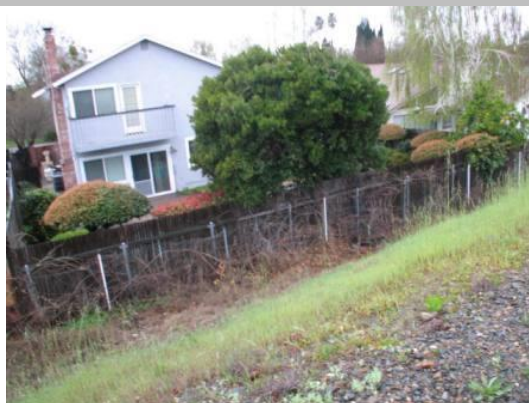
Photo 1 of 1 : SP\_2015\_NA0001\_55\_159\_20150317\_00139.jpg

LM Start	10.63	Rating **	U	Issue No.	159
LM End	10.63	Issue Type +	En	Location *	LS
Category	Earthen Levee			GPS Latitude/Longitude	
				Start	End
Item	Encroachments			38.568313 °	38.568313 °
				-121.352941 °	-121.352941 °
DWR ID	DWR_NA0001_04_s _ 2012_159				
Action/Comments					
Fence					
Inspector Comments: Wooden privacy fence within 10-ft of levee toe.

03/16/2012 Wood privacy fence completely obstructs access and visibility.

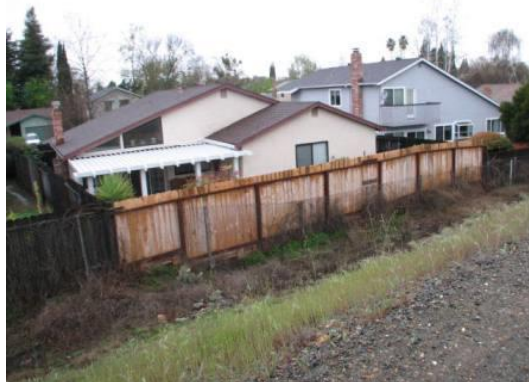
Photo 1 of 1 : SP\_2015\_NA0001\_55\_160\_20150317\_00140.jpg

LM Start	10.64	Rating **	U	Issue No.	160
LM End	10.64	Issue Type +	En	Location *	LS
Category	Earthen Levee			GPS Latitude/Longitude	
				Start	End
Item	Encroachments			38.568188 °	38.568188 °
				-121.352864 °	-121.352864 °
DWR ID	DWR_NA0001_04_f_2012_160				
Action/Comments					
Fence					
Inspector Comments: Tall wooden privacy fence within 10-ft of levee toe.

03/16/2012 Wood privacy fence completely obstructs access and visibility.

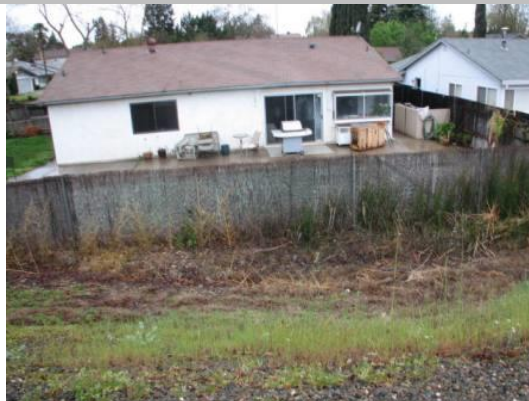
Photo 1 of 1 : SP\_2015\_NA0001\_55\_179\_20150317\_00157.jpg

LM Start	10.66	Rating **	U	Issue No.	179
LM End	10.66	Issue Type +	En	Location *	LS
Category	Earthen Levee			GPS Latitude/Longitude	
				Start	End
Item	Encroachments			38.567917 °	38.567917 °
				-121.352698 °	-121.352698 °
DWR ID	DWR_NA0001_04_s_2012_179				
Action/Comments					
Fence					
Inspector Comments: Chainlink fence with bamboo mats prevent visibility.

03/16/2012 Bamboo panels on chainlink fence completely obstruct visibility.

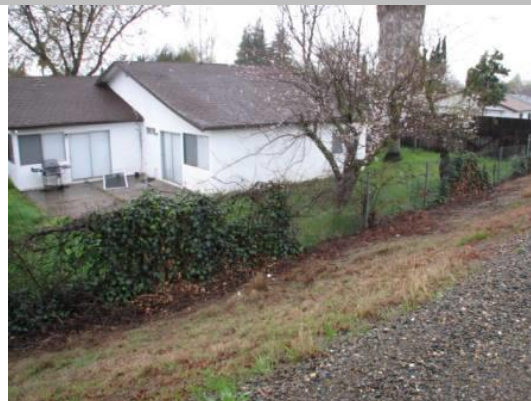
Photo 1 of 1 : SP\_2015\_NA0001\_55\_178\_20150317\_00156.jpg

LM Start	10.68	Rating **	M	Issue No.	178
LM End	10.68	Issue Type +	En	Location *	LS
Category	Earthen Levee			GPS Latitude/Longitude	
				Start	End
Item	Encroachments			38.567552 °	38.567552 °
				-121.352500 °	-121.352500 °
DWR ID	DWR_NA0001_04_s_2012_178				
Action/Comments					
Fence					
Inspector Comments: Chainlink fence

03/16/2012 Chainlink fence partially blocks visibility.

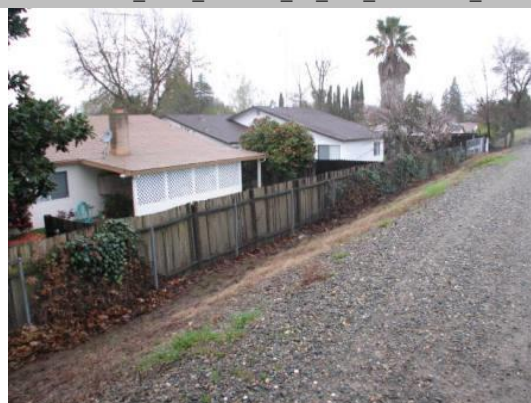
Photo 1 of 1 : SP\_2015\_NA0001\_55\_162\_20150317\_00142.jpg

LM Start	10.70	Rating **	U	Issue No.	162
LM End	10.70	Issue Type +	En	Location *	LS
Category	Earthen Levee			GPS Latitude/Longitude	
				Start	End
Item	Encroachments			38.567402 °	38.567402 °
				-121.352415 °	-121.352415 °
DWR ID	DWR_NA0001_04_s_2012_162				
Action/Comments					
Fence					
Inspector Comments: Wooden privacy fence within 10-ft of levee toe.

03/16/2012 Wood privacy fence completely obstructs access and visibility.

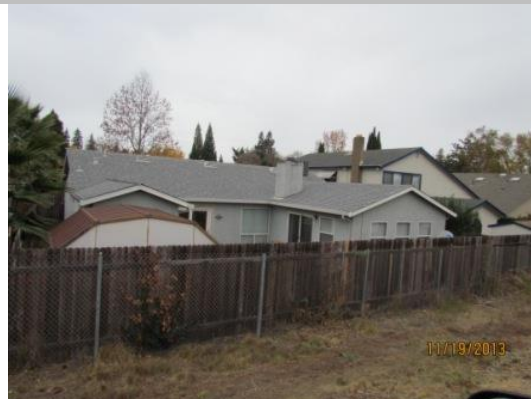
Photo 1 of 1 : SP\_2015\_NA0001\_55\_170\_20150317\_00149.jpg

LM Start	10.73	Rating **	U	Issue No.	170
LM End	10.73	Issue Type +	En	Location *	LS
Category	Earthen Levee			GPS Latitude/Longitude	
				Start	End
Item	Encroachments			38.566981 °	38.566981 °
				-121.352213 °	-121.352213 °
DWR ID	DWR_NA0001_04_f_2012_170				
Action/Comments					
Fence					
Inspector Comments: Wooden privacy fence within 10-ft of levee toe.

View of the fence obstructing visibility and access.

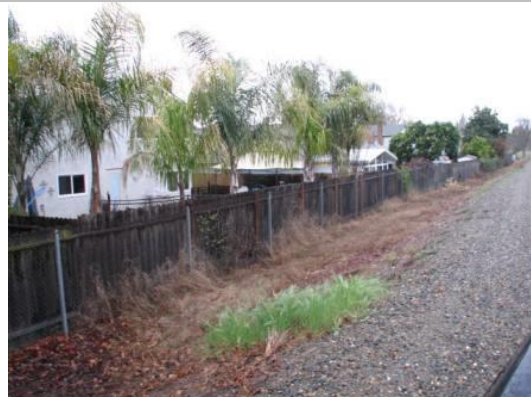
Photo 1 of 1 : SP\_2015\_NA0001\_55\_166\_20150317\_00145.jpg

LM Start	10.75	Rating **	U	Issue No.	166
LM End	10.75	Issue Type +	En	Location *	LS
Category	Earthen Levee			GPS Latitude/Longitude	
				Start	End
Item	Encroachments			38.566705 °	38.566705 °
				-121.352063 °	-121.352063 °
DWR ID	DWR_NA0001_04_s_2012_166				
Action/Comments					
Fence					
Inspector Comments: Wooden privacy fence within 10-ft of levee toe.

03/16/2012 Wood privacy fence completely obstructs access and visibility.

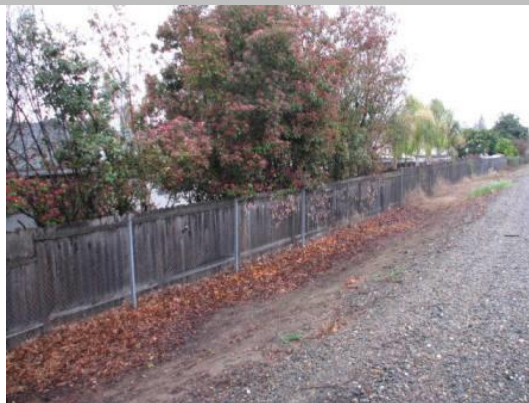
Photo 1 of 1 : SP\_2015\_NA0001\_55\_171\_20150317\_00150.jpg

LM Start	10.76	Rating **	U	Issue No.	171
LM End	10.76	Issue Type +	En	Location *	LS
Category	Earthen Levee			GPS Latitude/Longitude	
				Start	End
Item	Encroachments			38.566545 °	38.566545 °
				-121.352004 °	-121.352004 °
DWR ID	DWR_NA0001_04_s _ 2012_171				
Action/Comments					
Fence					
Inspector Comments: Wooden privacy fence and tall hedge within 10-ft of levee toe.

03/16/2012 Wood privacy fence completely obstructs access and visibility.

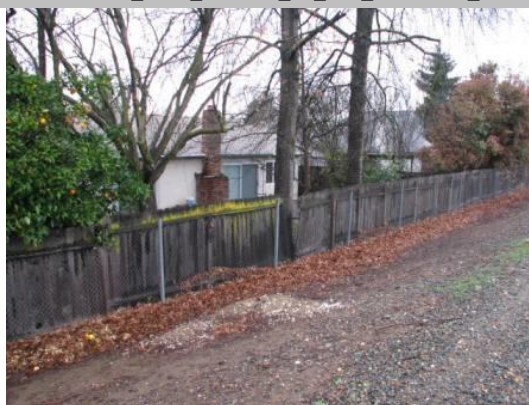
Photo 1 of 1 : SP\_2015\_NA0001\_55\_169\_20150317\_00148.jpg

LM Start	10.77	Rating **	U	Issue No.	169
LM End	10.77	Issue Type +	En	Location *	LS
Category	Earthen Levee			GPS Latitude/Longitude	
				Start	End
Item	Encroachments			38.566399 °	38.566399 °
				-121.351931 °	-121.351931 °
DWR ID	DWR_NA0001_04_s _ 2012_169				
Action/Comments					
Fence					
Inspector Comments: Wooden privacy fence within 10-ft of levee toe.

03/16/2012 Wood privacy fence completely obstructs access and visibility.

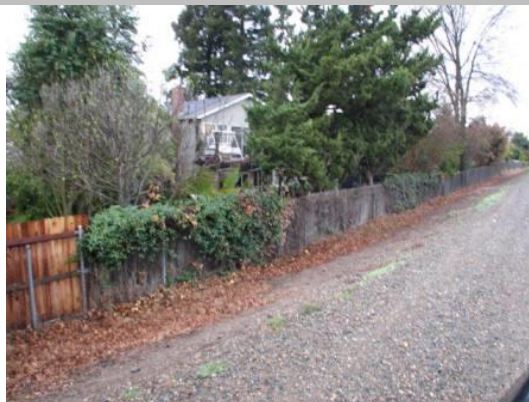
Photo 1 of 1 : SP\_2015\_NA0001\_55\_167\_20150317\_00146.jpg

LM Start	10.78	Rating **	U	Issue No.	167
LM End	10.78	Issue Type +	En	Location *	LS
Category	Earthen Levee			GPS Latitude/Longitude	
				Start	End
Item	Vegetation			38.566233 °	38.566233 °
				-121.351848 °	-121.351848 °
DWR ID	DWR_NA0001_04_s _ 2012_167				
Action/Comments					
Landscaping					
Inspector Comments: Wooden privacy fence ivy and vine planted within 10-ft of levee toe.

03/16/2012 Wood privacy fence completely obstructs access and visibility.

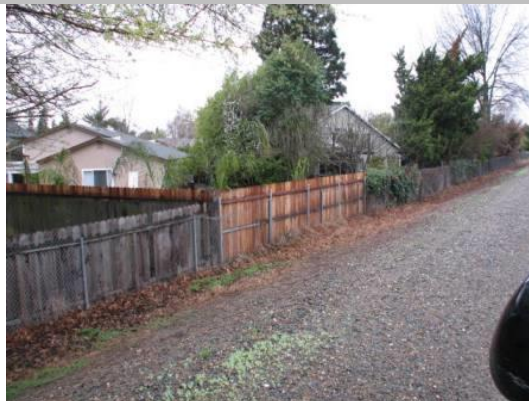
Photo 1 of 1 : SP\_2015\_NA0001\_55\_165\_20150317\_00144.jpg

LM Start	10.80	Rating **	U	Issue No.	165
LM End	10.80	Issue Type +	En	Location *	LS
Category	Earthen Levee			GPS Latitude/Longitude	
				Start	End
Item	Encroachments			38.566044 °	38.566044 °
				-121.351747 °	-121.351747 °
DWR ID	DWR_NA0001_04_s _ 2012_165				
Action/Comments					
Fence					
Inspector Comments: Wooden privacy fence within 10-ft of levee toe.

03/16/2012 Wood privacy fence completely obstructs access and visibility.

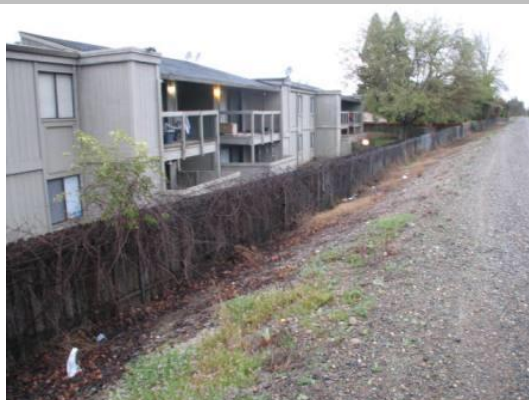
Photo 1 of 1 : SP\_2015\_NA0001\_55\_168\_20150317\_00147.jpg

LM Start	10.81	Rating **	U	Issue No.	168
LM End	10.83	Issue Type +	En	Location *	LS
Category	Earthen Levee			GPS Latitude/Longitude	
				Start	End
Item	Encroachments			38.565917 °	38.565646 °
				-121.351682 °	-121.351532 °
DWR ID	DWR_NA0001_04_s _ 2012_168				
Action/Comments					
Fence					
Inspector Comments: Wooden privacy fence within 10-ft of levee toe.

03/16/2012 Wood privacy fence completely obstructs access and visibility.

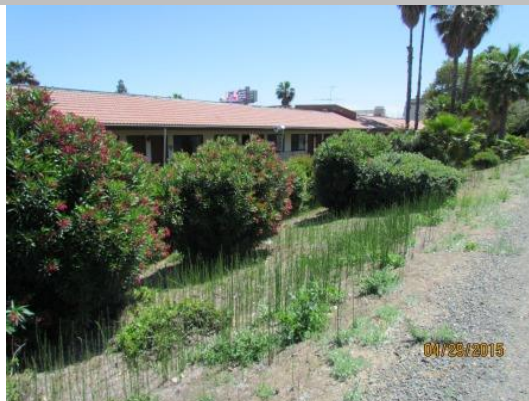
Photo 1 of 1 : SP\_2015\_NA0001\_56\_2\_20150504\_00003.jpg

LM Start	0.10	Rating **	M	Issue No.	2
LM End	0.17	Issue Type +	En	Location *	LS
Category	Earthen Levee			GPS Latitude/Longitude	
				Start	End
Item	Vegetation			38.595044 °	38.594117 °
				-121.506497 °	-121.506377 °
DWR ID	DWR_NA0001_05_s _ 2012_2				
Action/Comments					
Landscaping					
Inspector Comments: Landcaping behind Best Western.

View of the landscaping on the landside levee slope obstructing visibility and access.

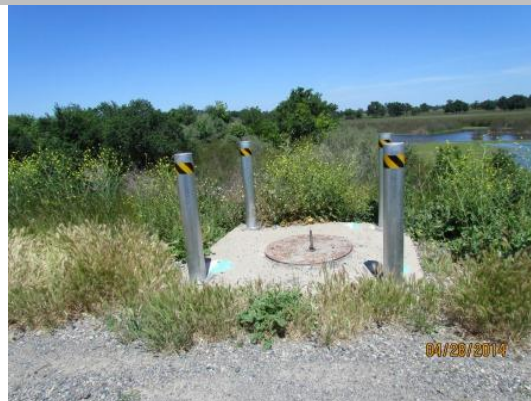
Photo 1 of 1 : SP\_2015\_NA0001\_57\_10\_20150317\_00002.jpg

LM Start	0.02	Rating **	A/W	Issue No.	10
LM End	0.02	Issue Type +	En	Location *	CR
Category	Earthen Levee			GPS Latitude/Longitude	
				Start	End
Item	Encroachments			38.657424 °	38.657424 °
				-121.474434 °	-121.474434 °
DWR ID	DWR_NA0001_06_s_2014_10				
Action/Comments					
Pipe

View of the pipe from the levee crown.

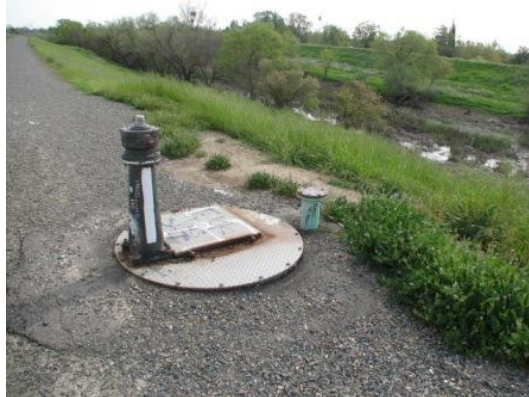
Photo 1 of 1 : SP\_2015\_NA0001\_58\_17\_20150317\_00016.jpg

LM Start	0.37	Rating **	A/W	Issue No.	17
LM End	0.37	Issue Type +	En	Location *	CR
Category	Earthen Levee			GPS Latitude/Longitude	
				Start	End
Item	Encroachments			38.623325 °	38.623325 °
				-121.462217 °	-121.462217 °
DWR ID	DWR_NA0001_07_s_2012_17				
Action/Comments					
Pipe Inspector Comments: Closure device for sewer line located on levee crown.

Closure device for SS beneath channel.

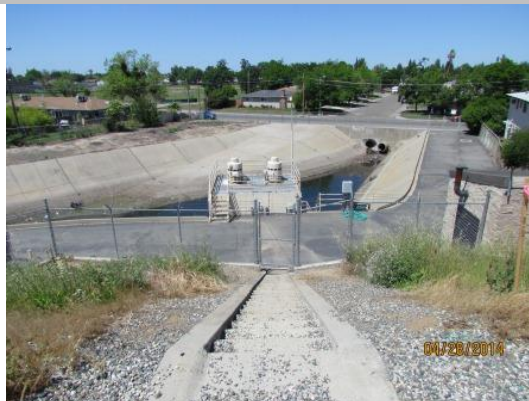
Photo 1 of 1 : SP\_2015\_NA0001\_58\_42\_20150317\_00030.jpg

LM Start	0.60	Rating **	A/W	Issue No.	42
LM End	0.60	Issue Type +	En	Location *	CR
Category	Earthen Levee			GPS Latitude/Longitude	
				Start	End
Item	Encroachments			38.625311 °	38.625311 °
				-121.458994 °	-121.458994 °
DWR ID	DWR_NA0001_07_s_2014_42				
Action/Comments					
Pipe Inspector Comments: Two pipes crossing the levee.

View of the pump station on the landside levee toe.

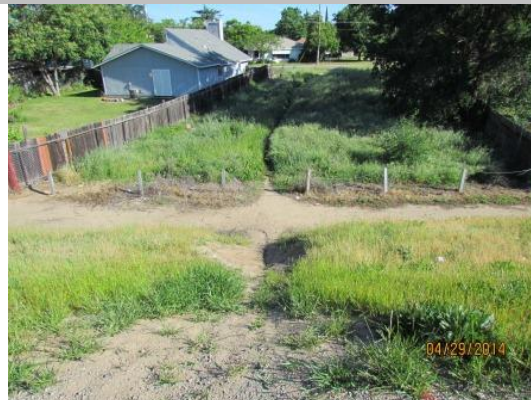
Photo 1 of 1 : SP\_2015\_NA0001\_58\_34\_20150317\_00029.jpg

LM Start	1.39	Rating **	A/W	Issue No.	34
LM End	1.39	Issue Type +	Ma	Location *	LS
Category	Earthen Levee			GPS Latitude/Longitude	
				Start	End
Item	Slope Stability			38.626601 °	38.626601 °
				-121.445016 °	-121.445016 °
DWR ID	DWR_NA0001_07_s_2012_34				
Action/Comments					
Repair the levee slope damaged by foot traffic and prevent access where possible.					
Inspector Comments: Damage caused by foot traffic.

View of the landside levee slope damaged by foot traffic.

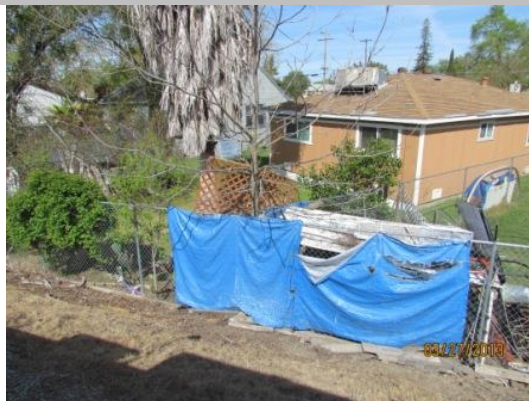
Photo 1 of 1 : SP\_2015\_NA0001\_58\_8\_20150317\_00006.jpg

LM Start	1.50	Rating **	M	Issue No.	8
LM End	1.50	Issue Type +	En	Location *	LS
Category	Earthen Levee			GPS Latitude/Longitude	
				Start	End
Item	Encroachments			38.627526 °	38.627526 °
				-121.443310 °	-121.443310 °
DWR ID	DWR_NA0001_07_s_2013_8				
Action/Comments					
Fence

View of the fence obstruction visibility and access at the landside levee toe.

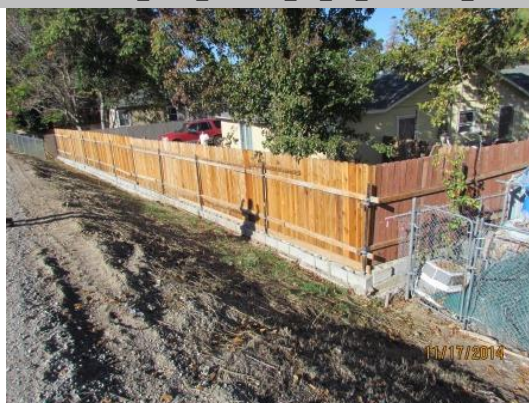
Photo 1 of 1 : SP\_2015\_NA0001\_58\_43\_20150317\_00031.jpg

LM Start	1.53	Rating **	U	Issue No.	43
LM End	1.54	Issue Type +	En	Location *	LS
Category	Earthen Levee			GPS Latitude/Longitude	
				Start	End
Item	Encroachments			38.627675 °	38.627718 °
				-121.442874 °	-121.442631 °
DWR ID	DWR_NA0001_07_s_2014_43				
Action/Comments					
Fence					
Inspector Comments: New fence constructed on the property line with 18 inch CMU block base.

View of a fence at the landside levee toe obstructing visibility and access.

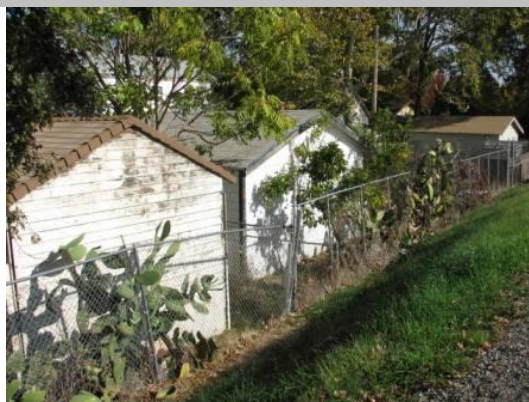
Photo 1 of 1 : SP\_2015\_NA0001\_58\_30\_20150317\_00027.jpg

LM Start	1.56	Rating **	U	Issue No.	30
LM End	1.56	Issue Type +	En	Location *	LS
Category	Earthen Levee			GPS Latitude/Longitude	
				Start	End
Item	Encroachments			38.627744 °	38.627744 °
				-121.442367 °	-121.442367 °
DWR ID	DWR_NA0001_07_s_2012_30				
Action/Comments					
Building					
Inspector Comments: Large side building is within 10-ft of the levee toe.

11/17/2011 Building obstructs visibility and access.

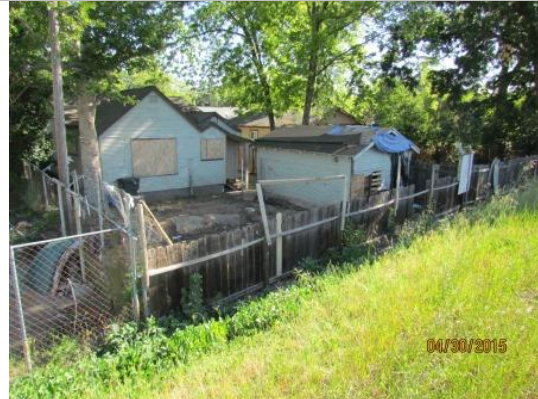
Photo 1 of 1 : SP\_2015\_NA0001\_58\_3\_20150504\_00036.jpg

LM Start	1.57	Rating **	U	Issue No.	3
LM End	1.57	Issue Type +	En	Location *	LS
Category	Earthen Levee			GPS Latitude/Longitude	
				Start	End
Item	Encroachments			38.627682 °	38.627682 °
				-121.442113 °	-121.442113 °
DWR ID	DWR_NA0001_07_s_2012_3				
Action/Comments					
Fence					
Inspector Comments: Wooden privacy fence is within 10-ft of the levee toe.

Wooden privacy fence is constructed at the landside levee toe.

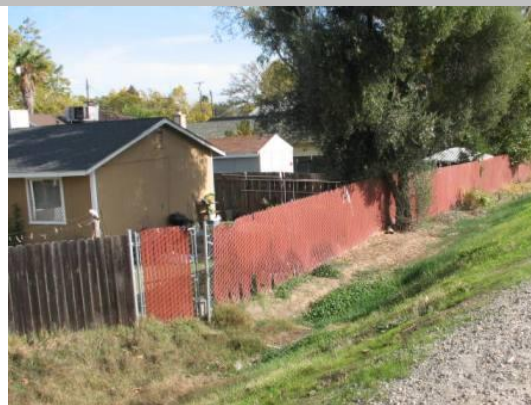
Photo 1 of 1 : SP\_2015\_NA0001\_58\_29\_20150317\_00026.jpg

LM Start	1.61	Rating **	M	Issue No.	29
LM End	1.61	Issue Type +	En	Location *	LS
Category	Earthen Levee			GPS Latitude/Longitude	
				Start	End
Item	Encroachments			38.627733 °	38.627733 °
				-121.441415 °	-121.441415 °
DWR ID	DWR_NA0001_07_s _ 2012_29				
Action/Comments					
Fence					
Inspector Comments: Privacy fence is within 10-ft of the levee toe.

11/17/2011 Privacy fence is constructed at the toe.

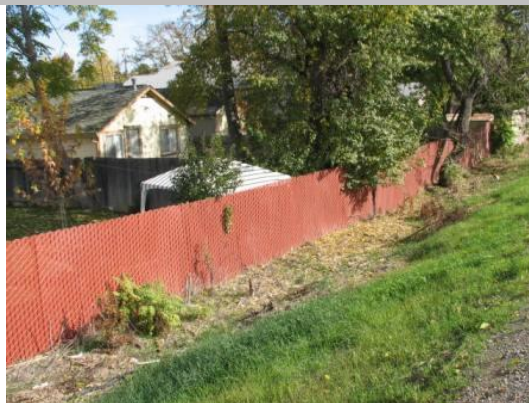
Photo 1 of 1 : SP\_2015\_NA0001\_58\_28\_20150317\_00025.jpg

LM Start	1.63	Rating **	M	Issue No.	28
LM End	1.63	Issue Type +	En	Location *	LS
Category	Earthen Levee			GPS Latitude/Longitude	
				Start	End
Item	Encroachments			38.627668 °	38.627668 °
				-121.441018 °	-121.441018 °
DWR ID	DWR_NA0001_07_s _ 2012_28				
Action/Comments					
Fence					
Inspector Comments: Privacy fence is within 10-ft of the levee toe.

11/17/2011 Privacy fence is constructed at the toe.

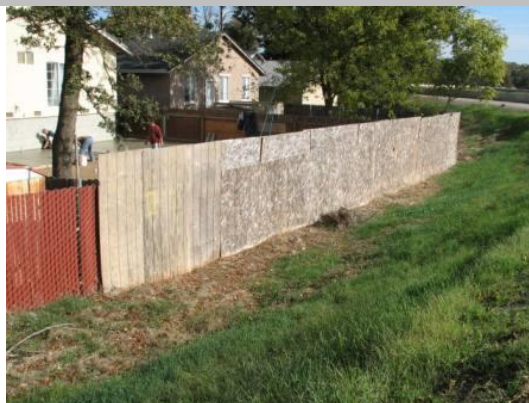
Photo 1 of 1 : SP\_2015\_NA0001\_58\_26\_20150317\_00023.jpg

LM Start	1.64	Rating **	U	Issue No.	26
LM End	1.64	Issue Type +	En	Location *	LS
Category	Earthen Levee			GPS Latitude/Longitude	
				Start	End
Item	Encroachments			38.627663 °	38.627663 °
				-121.440784 °	-121.440784 °
DWR ID	DWR_NA0001_07_s _ 2012_26				
Action/Comments					
Fence					
Inspector Comments: Wooden privacy fence is within 10-ft of the levee toe.

11/17/2011 Wooden privacy fence is constructed at the toe.

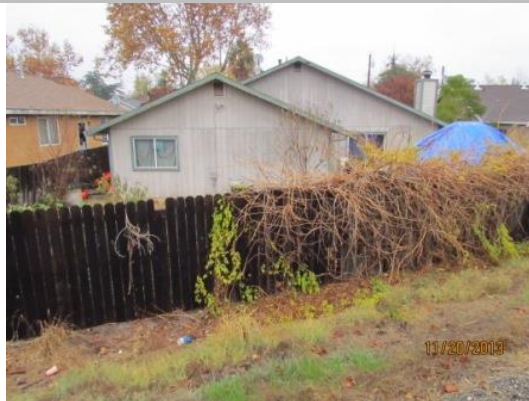
Photo 1 of 1 : SP\_2015\_NA0001\_58\_6\_20150317\_00004.jpg

LM Start	1.69	Rating **	U	Issue No.	6
LM End	1.69	Issue Type +	En	Location *	LS
Category	Earthen Levee			GPS Latitude/Longitude	
				Start	End
Item	Encroachments			38.627948 °	38.627948 °
				-121.439958 °	-121.439958 °
DWR ID	DWR_NA0001_07_s _ 2012_6				
Action/Comments					
Fence					
Inspector Comments: Wooden privacy fence with vines are within 10-ft of the levee toe.

View of the wooden fence at the landside levee toe.

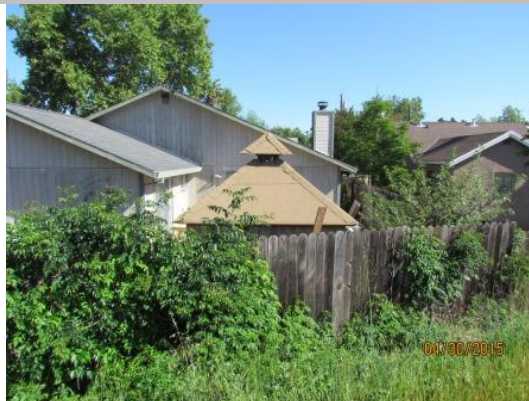
Photo 1 of 1 : SP\_2015\_NA0001\_58\_1\_20150504\_00037.jpg

LM Start	1.69	Rating **	U	Issue No.	1
LM End	1.69	Issue Type +	En	Location *	LS
Category	Earthen Levee			GPS Latitude/Longitude	
				Start	End
Item	Encroachments			38.628004 °	38.628004 °
				-121.439927 °	-121.439927 °
DWR ID	DWR_NA0001_07_s _ 2012_1				
Action/Comments					
Building Inspector Comments: Construction of new structure is witin 15' of levee.

View of the shed at the landside levee toe.

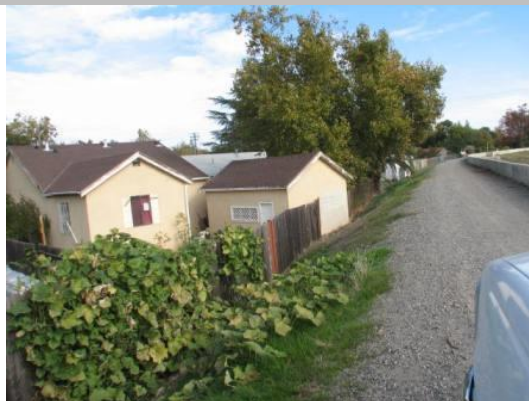
Photo 1 of 1 : SP\_2015\_NA0001\_58\_7\_20150317\_00005.jpg

LM Start	1.70	Rating **	U	Issue No.	7
LM End	1.70	Issue Type +	En	Location *	LS
Category	Earthen Levee			GPS Latitude/Longitude	
				Start	End
Item	Encroachments			38.627935 °	38.627935 °
				-121.439758 °	-121.439758 °
DWR ID	DWR_NA0001_07_s _ 2012_7				
Action/Comments					
Building					
Inspector Comments: Corner of building protrudes into levee slope.					
Wooden fence is built on the levee slope.

11/17/2011 Building is constructed at the toe.
